## Spark Plug Inspection

### Inspection

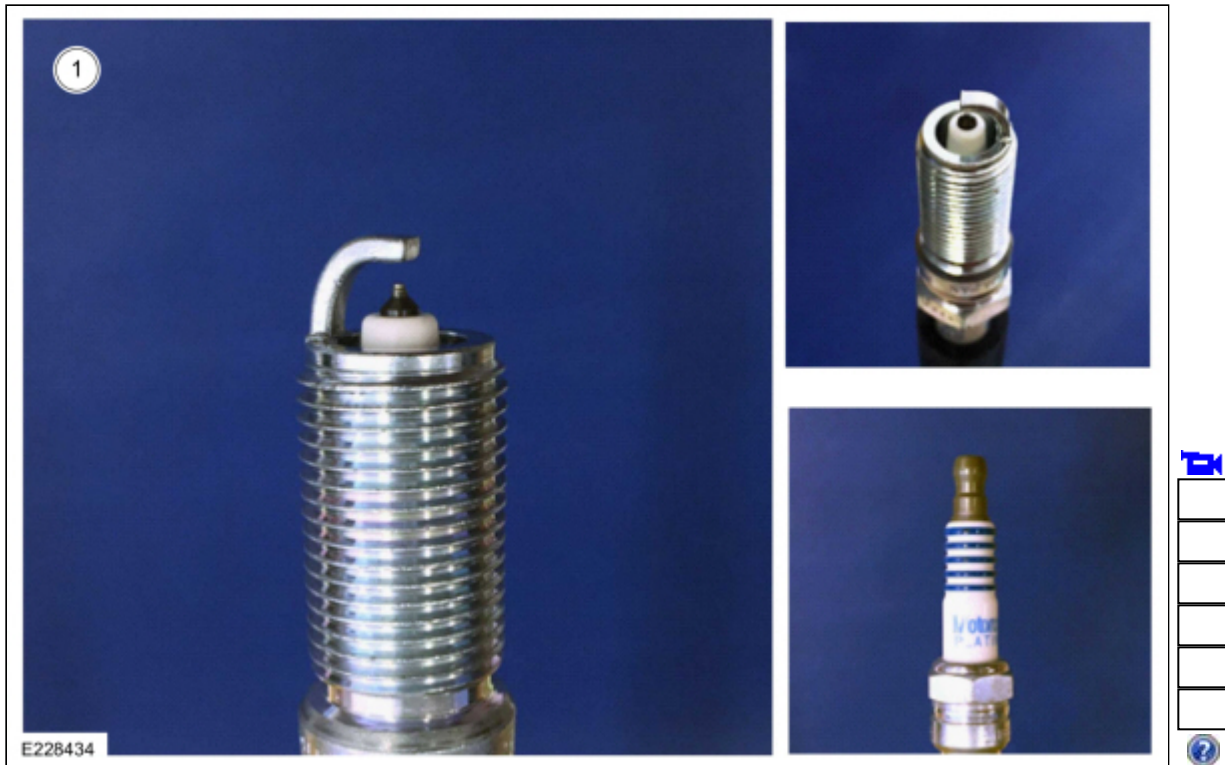
#### Unfired

1.
  - An unfired spark plug should appear very clean with a pure nickel finish to the threads and ground strap. The center electrode ceramic insulator surface is often a matte or dull finish and pure white in color. The external primary insulator is often a polished white ceramic with appropriate stamping labels. Some spark plugs have a smooth barrel while others have a ribbed barrel insulator. Ford spark plugs almost universally use a ribbed barrel with glazed blue rib peaks. The Anti-Fouling silicone oil treatment used on all Ford spark plugs may be tinted pink. Some suppliers use this to designate the silicone oil has been applied.
  - No corrective action necessary.

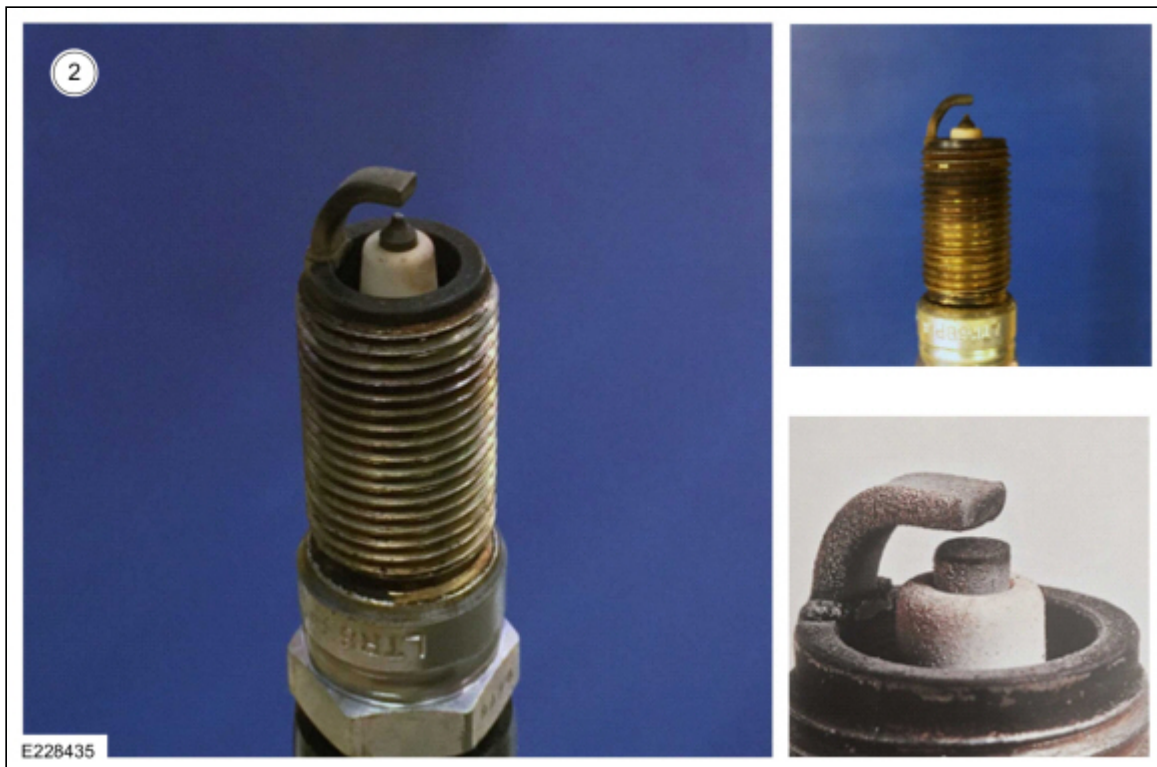
### Normal Burning

2.
  - A normal burning spark plug will often present with a white or slightly off-white (brown or light gray) color center electrode and clean or mildly discolored ground strap.
  - No corrective action necessary.

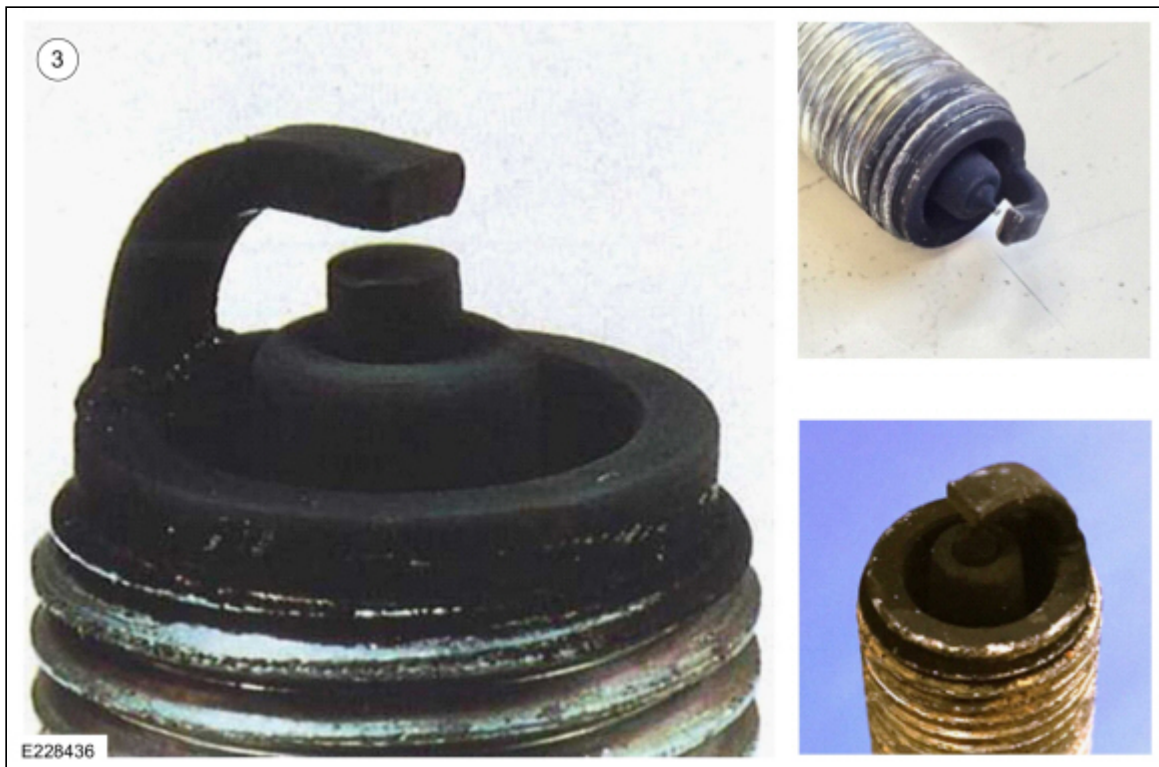
### Carbon Fouling

- Carbon fouling can cause engine misfire. As carbon deposits, created during incomplete combustion, adhere to center electrode insulator surfaces, insulator dielectric and isolation or shunt resistance are compromised. In the case that sufficient carbon deposits are present on the center electrode and insulator surface the primary conduction path can change from spark creation to shorting through carbon deposits. This is also known as spark leakage. Upon shorting through carbon deposits, available voltage delivered to the center electrode tip is reduced until no spark is delivered to the mixture and a misfire occurs. Proper Heat Range selection is necessary to avoid pre-ignition and carbon fouling. Even with the proper Heat Range, avoid excessive cold starts and/or excessive idling at cold engine temperatures without a warm-up drive cycle. For proper self-cleaning, be sure to warm the spark plug using a medium-load drive cycle. A normal operating temperature for a spark plug may be 450-850°C (842-1562°F), at which point carbon deposits will burn off during spark plug self-cleaning.

- A drive cycle of enough distance and rpm can clear the spark plugs of carbon fouling (ex: 4 mile drive at 3000 rpm).
- Should this fail, install new spark plugs.

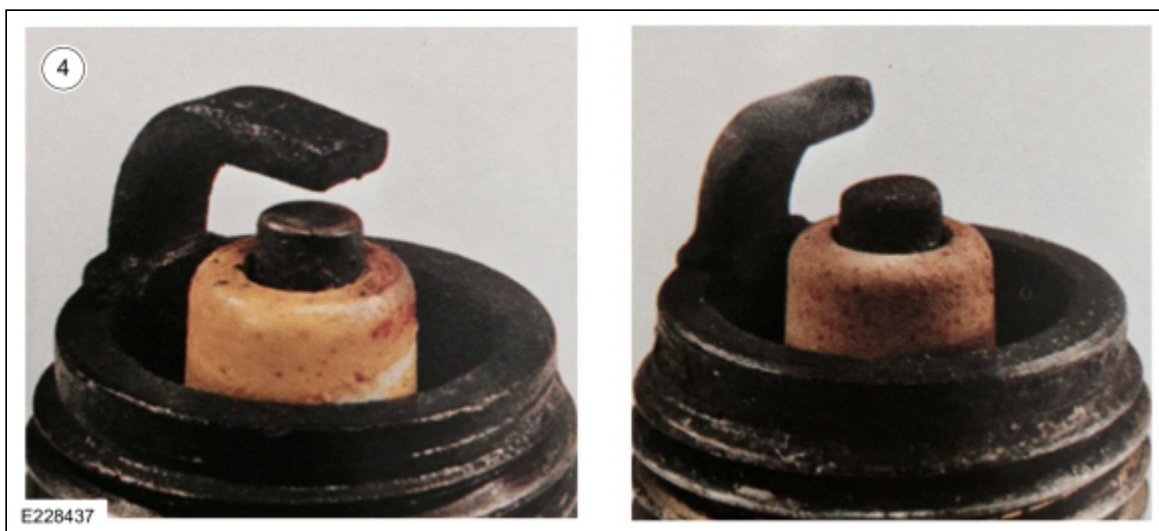
### Lead Fouling and Erosion

- Lead fouling can occur in engines that use leaded gasoline. In modern engine applications, this failure mode is rare, as TEL (Tetraethyllead) was removed from consumer use at fuel filling stations long ago. Lead fouling can occur on engines used in high compression racing engines and, in some limited cases, aviation applications. Spark plugs that have been used in the presence of lead are characteristically identified by a yellow/brown tinted center electrode insulator and can cause engine misfire at high engine speed and high load. Additionally, ground strap electrodes will often be worn in engines exposed to leaded fuel for extended periods of time. This failure mode is caused by the tendency for lead compounds to react chemically with nickel electrode materials at high temperatures. These chemical reactions often cause increased brittleness and reduced material strength in the ground electrode.

- Alert the customer to avoid using leaded fuel and/or octane enhancer.
- Inspect the CMS (catalyst monitor sensor) and the HO2S for evidence of lead damage.

- Install new spark plugs.

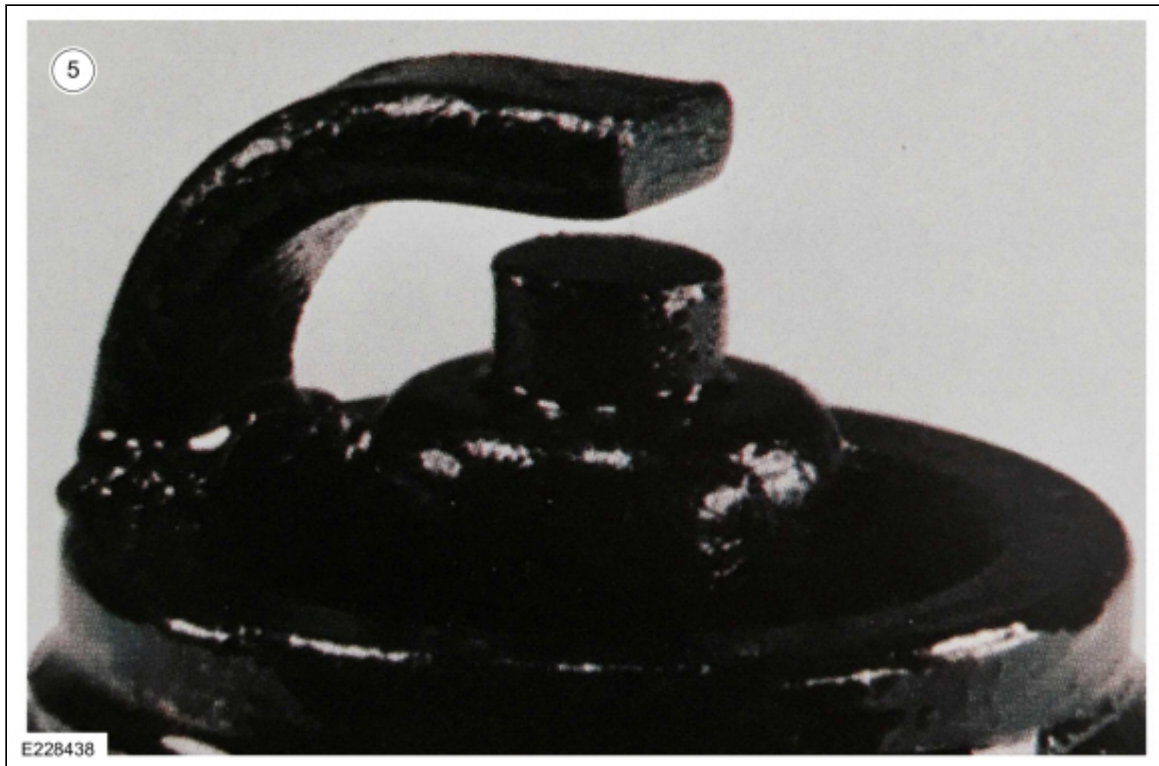
### Coolant/Oil Wet Fouling

- Wet fouling is most often caused by excess fuel, oil, or coolant within the combustion chamber during operation. Spark plugs that are wet fouled often cause poor starting and misfiring. Often, a wet fouled spark plug is indicative of additional mechanical issues within the engine system such as a compromised head gasket, oil leakage past the control ring, or valve train leakage. In certain cases, other causes could be low compression, vacuum leaks, overly retarded timing, or improper spark plug heat range. The primary cause of misfire is the low resistance path created by oil, fuel, or coolant deposits. Wet materials provide a lower resistance path for spark leakage from the high voltage center electrode to ground. When driving with a coolant leak for an extended time, the plug may be cleaned.

- Check for wet, black deposits on the insulator shell bore electrodes, caused by excessive oil entering the combustion chamber through worn rings and pistons, excessive valve-to-guide clearance or worn or loose bearings.

- Correct the coolant or oil leak concern.
- Install new spark plugs.

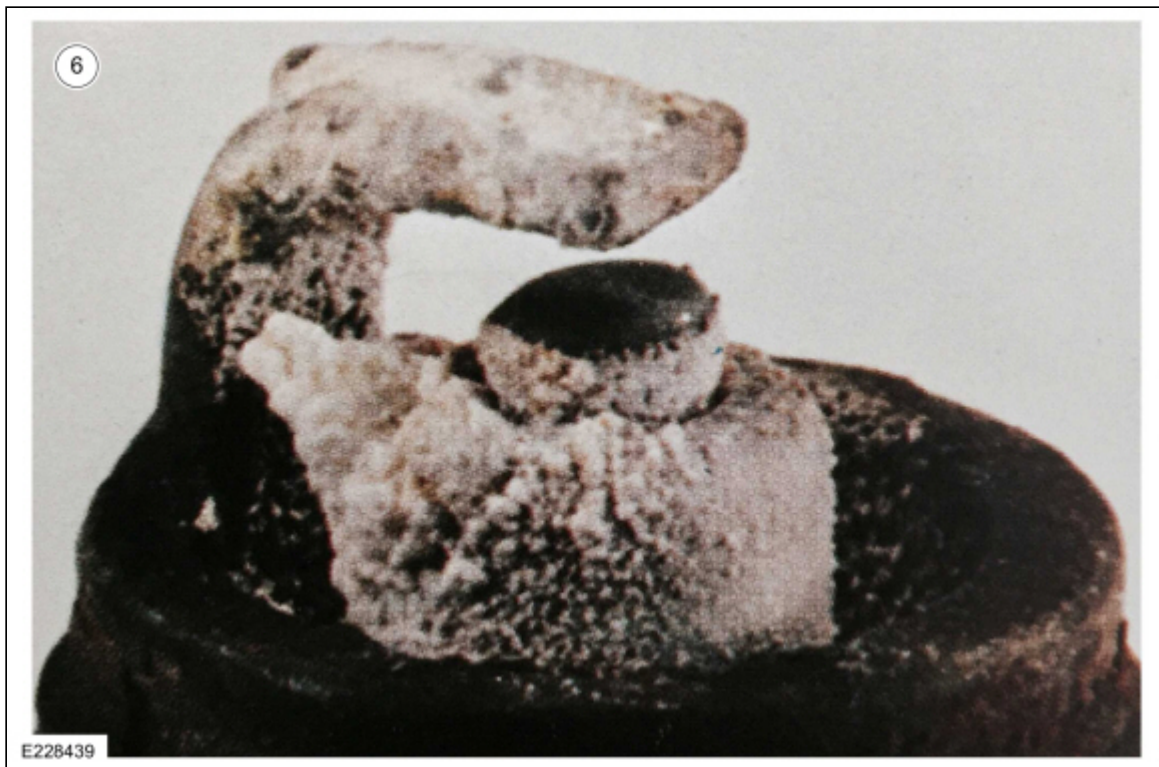
### Deposit Buildup

6.
  - The presence of deposits on the spark plug can be indicative of oil leakage or poor fuel quality. Often, these ashy coatings cause misfires as a low resistance path from center electrode to ground is created.
  - Correct the oil leak, if necessary.
  - Inform the customer of possible poor quality fuel.
  - Install new spark plugs.

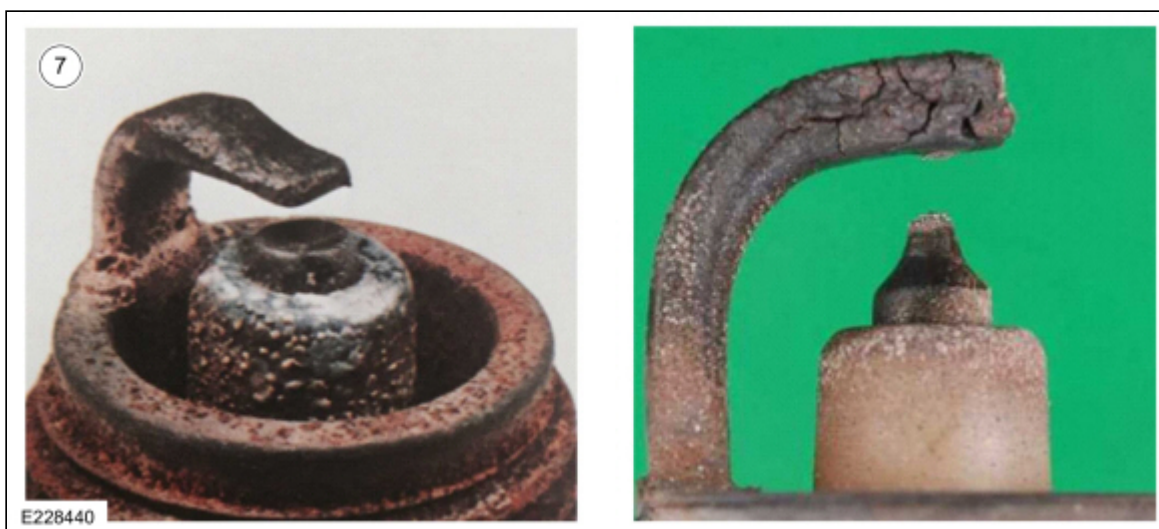
### Abnormal Erosion/Corrosion/Oxidation

- Often, eroded, corroded, or oxidized spark plug conditions occur as a result of leaded gasoline, which reacts with electrode materials (see Lead Fouling). These symptoms appear as pitted, cracked, or eroded electrodes and on occasion will display with a green cast if copper oxidation is heavy. These conditions result in increased, improper spark plug gap and yield poor performance. More recently, the use of Ethanol fuel blends of E85 (85% Ethanol) can create this Oxidation condition. The Heat Range selection for E85 applications typically is 1 range colder due to added spark advance used to make up for the loss of performance. The hotter tip temperatures combined with the rapid thermal cycle on the electrode surface initiates surface cracks and eventual oxidation based corrosion.

- Verify E85 isn't being used in a vehicle not designated for E85 usage (Flex Fuel Vehicle).
- Install new spark plugs.

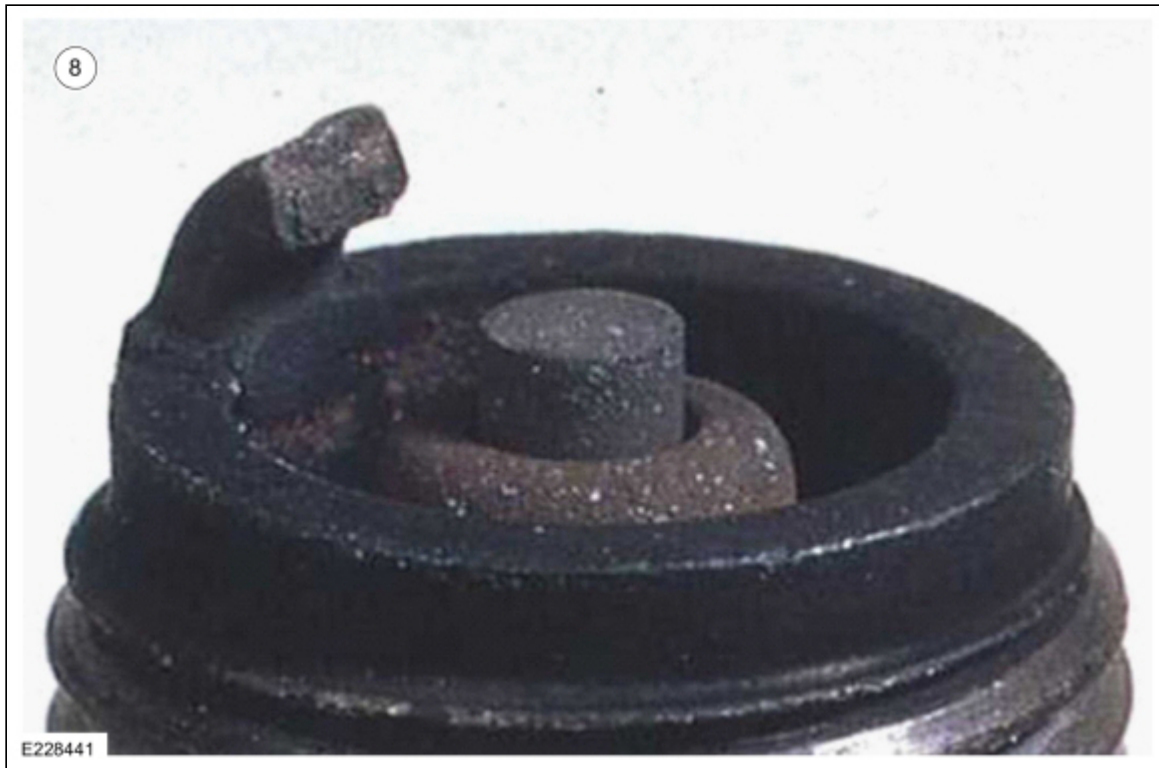
### Ground Electrode Breakage

- Ground electrode breakage can be caused by pre-ignition or any other excess shock load. Ground electrode breaks may be caused by incorrect ignition timing, wrong type of fuel, or unauthorized installation of a reduced thermal conductivity Heli-Coil insert in place of the spark plug threads.

- Confirm the proper fuel and ignition timing.
- Confirm the proper heat range of spark plugs.
- Confirm that the cylinder head threads have not been repaired with a Heli-Coil thread repair kit.
- Install new spark plugs.

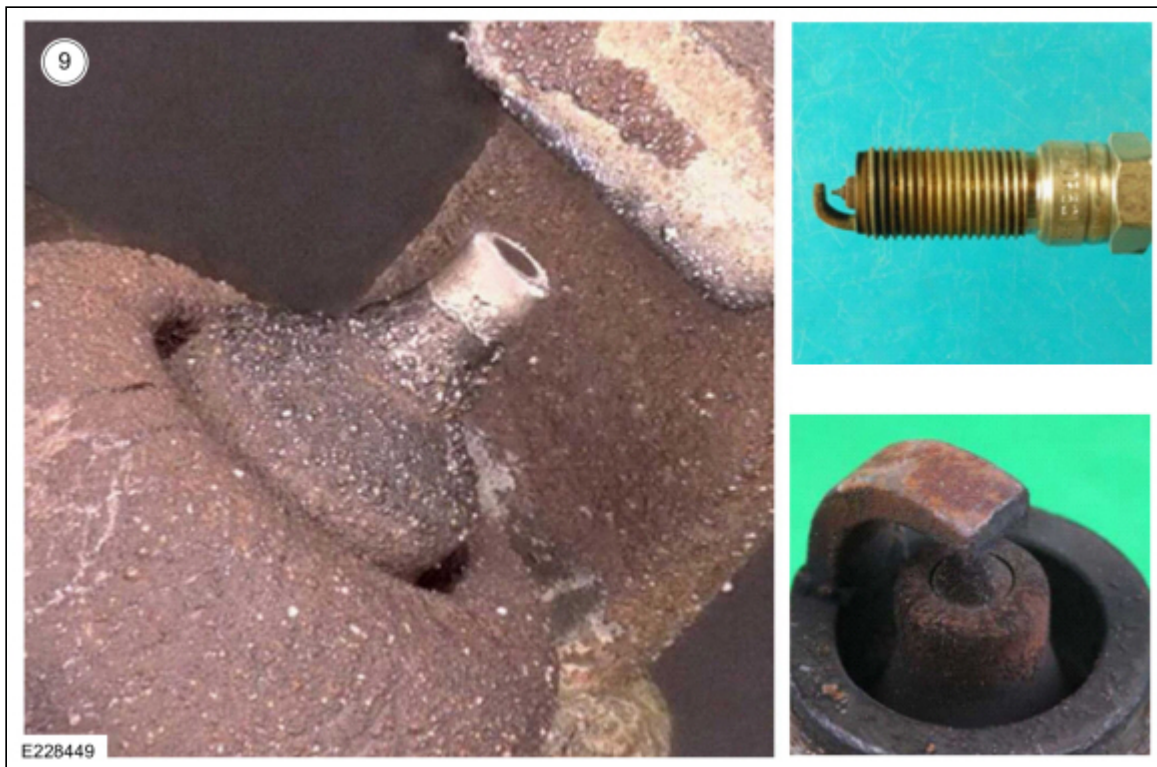
### MMT Fouling (Hot Plug Fouling)

- MMT (Methylcyclopentadienyl Manganese Tricarbonyl) is often used as an octane booster in combination with poor quality fuels to bring octane levels within acceptable limits. If excess Mn (Manganese) levels are present in the fuel during combustion, Mn deposits can foul the combustion chamber, catalytic converters, and spark plugs. Mn in higher concentrations can lead to pre-ignition and engine misfire. Mn deposit become conductive as the surface exceeds  $\sim 550^{\circ}\text{C}$  ( $1022^{\circ}\text{F}$ ). For this reason the failure mode is referred to as Hot Plug Fouling. As MMT is high in manganese, a reddish coating will be present on the spark plug insulator and ground electrodes. The reddish coating is often covered up by carbon fouling if the spark plug is to the point of misfire.

- Advise the customer to avoid use of leaded fuel and/or octane enhancer.
- Inspect the CMS and the HO2S for evidence of MMT damage.
- Install new spark plugs.

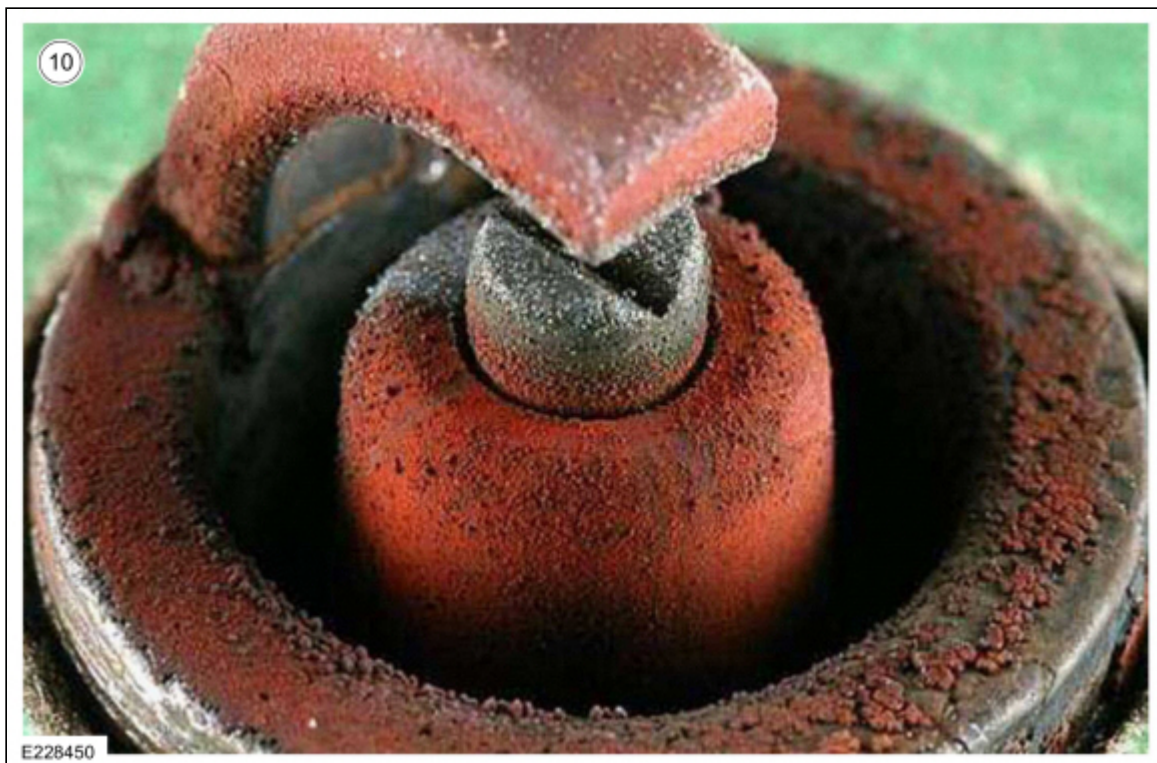
### Ferrocene Fouling (Hot Plug Fouling)

- Ferrocene (metallocene) is an organometallic compound often used in place of MMT as an octane booster and presents itself with a bright orange surface color. If excess ferrocene levels are present in the fuel during combustion, ferrocene deposits can foul the combustion chamber, catalytic converters, and spark plugs. Deposit become conductive as the surface exceeds  $\sim 450^{\circ}\text{C}$  ( $842^{\circ}\text{F}$ ). For this reason the failure mode is referred to as Hot Plug Fouling. Ferrocene in higher concentrations can lead to pre-ignition and engine misfire.
- Advise the customer that they may be using leaded fuel and/or octane enhancer. Ask them to stop.
- Inspect the CMS and the HO2S for evidence of ferrocene damage.
- Install new spark plugs.

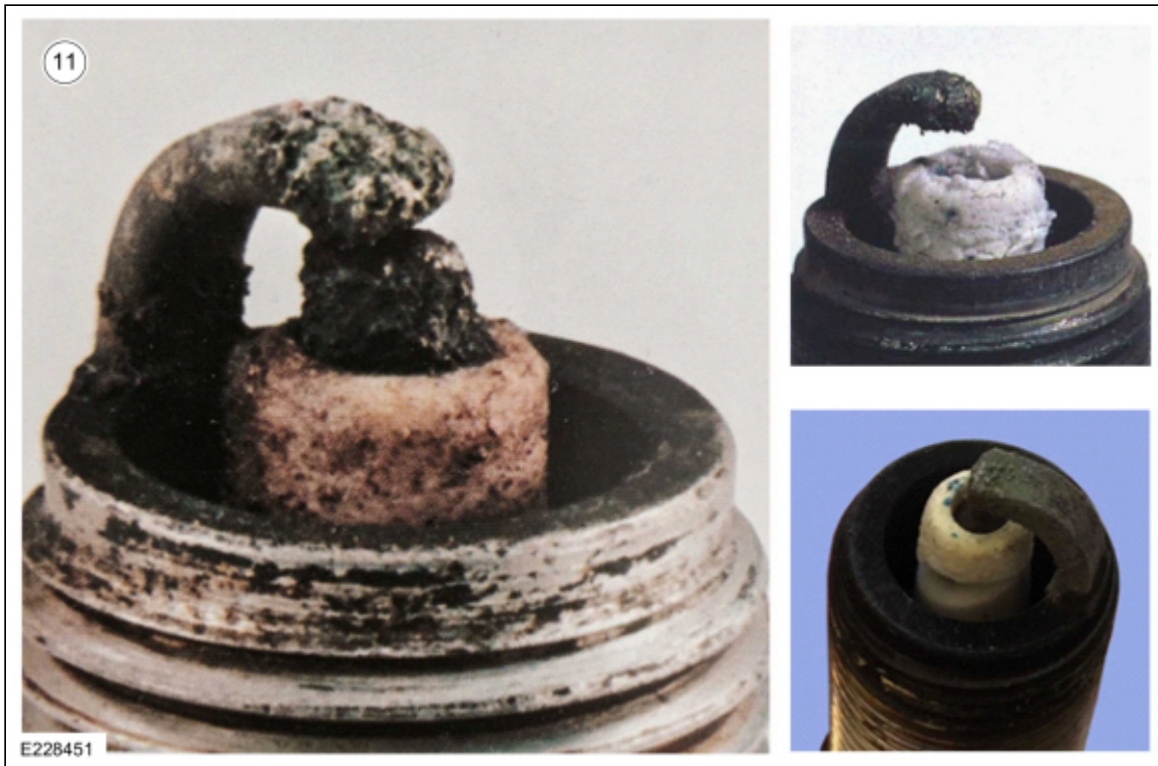
## Overheating and Melted Electrodes

- Symptoms of overheating include white or light gray spots and a bluish-burnt appearance of the electrodes. This is caused by engine overheating, wrong type of fuel, loose spark plugs, spark plugs with an incorrect heat range, low fuel pump pressure, or incorrect ignition timing. Fused deposits present with melted or spotty deposits resembling bubbles or blisters and are indicative of sudden acceleration.
- Confirm proper fuel and ignition timing.
- Confirm proper heat range of spark plugs.
- Check the coolant system for leaks and blockages, and check water pump for malfunction.
- Repair coolant system and refill coolant, as necessary.
- Install new spark plugs.

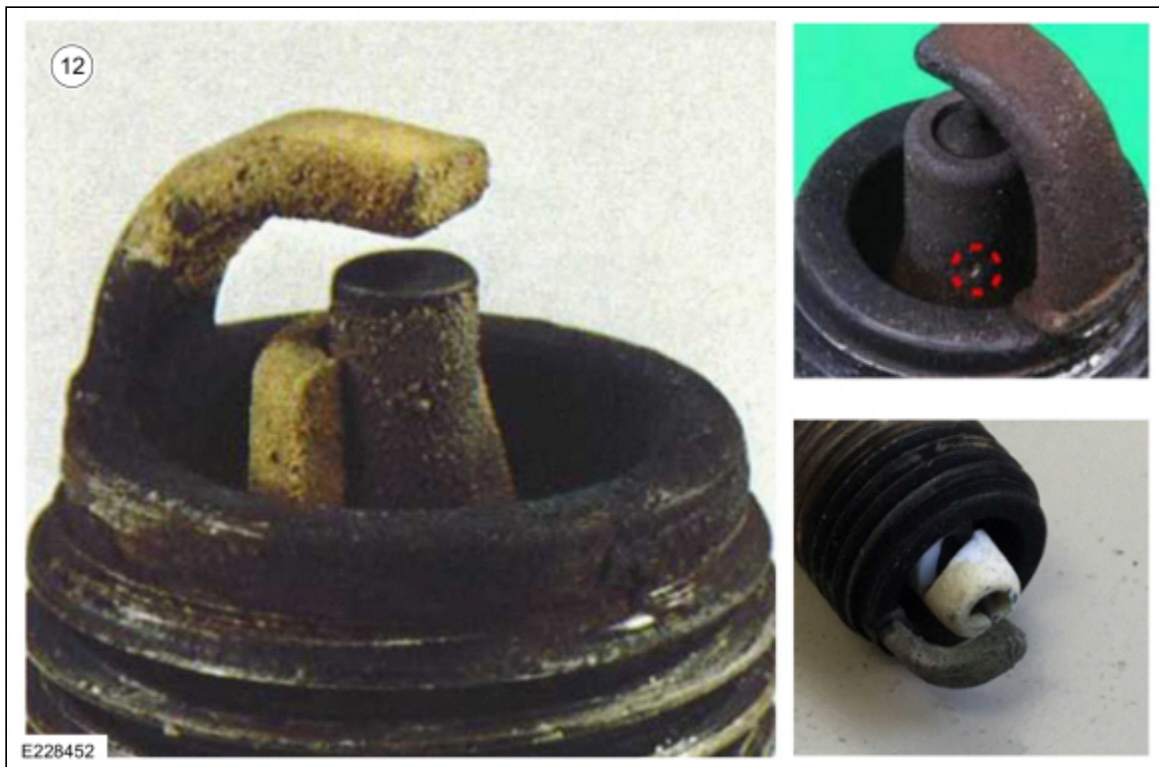
## Insulator Damage and Breakage

12. **NOTE:** Upper right hand insert shows dielectric puncture typically due to excessively worn gaps.

- Center electrode insulator breakage is often caused by a sudden thermal shock due to sudden heating or cooling. It can also be caused by mechanical load from an external source (droppage) or can even be caused by pre-ignition events where side loading from combustion pressure shock waves is strong enough to fracture the ceramic insulator material. Hotter heat range spark plugs have a longer insulator to reduce the spark plug fouling risk, but are also weaker to fracture during low speed pre-ignition events due to increase bending moment arm. Oil or Sulfur Oxide migration between the center electrode and the inner diameter of the insulator can cause internal outward force sufficient to create a “u” shaped fracture. See Sodium/Oil Migration section for further detail of this failure mode.
- Install new spark plugs.

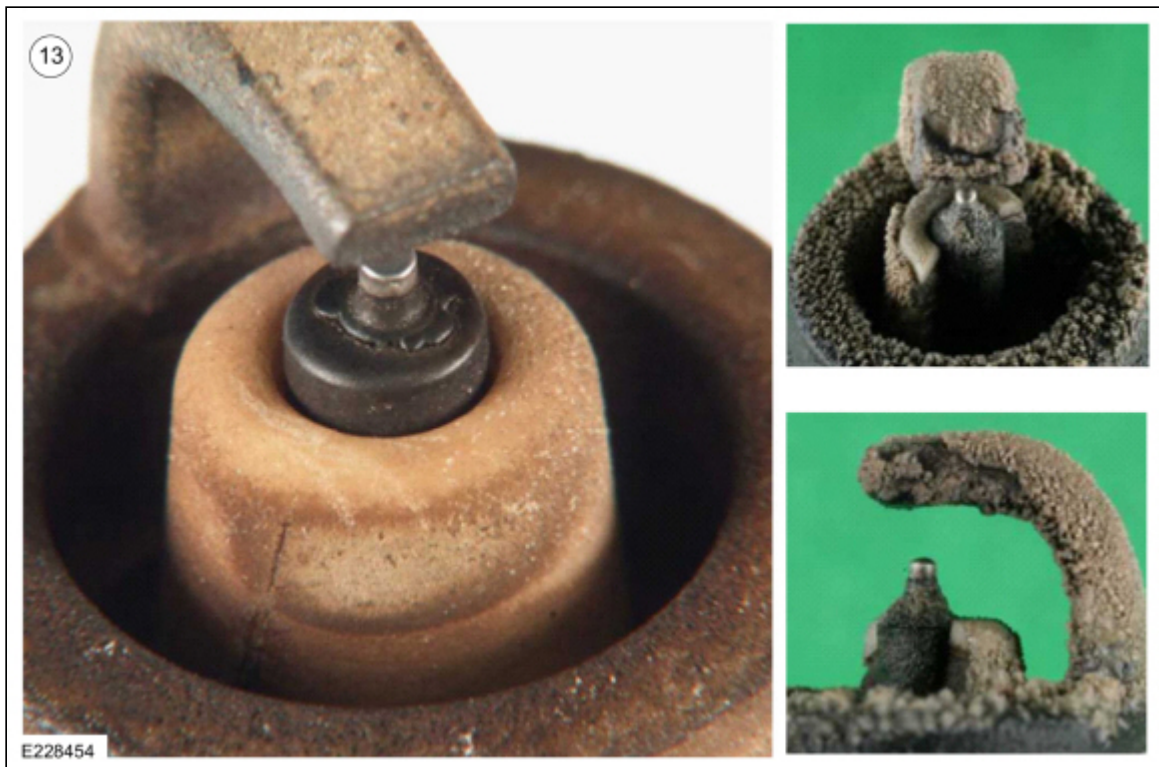
### Sodium/Oil Migration

- In the case of oil migration, misted oil is absorbed into the combustion chamber during charge intake. For cylinder deactivation, valves remain closed and oil within the chamber does not combust. Misted oil adheres to the spark plug surfaces and oil penetrates into the clearance volume between the insulator and center electrode via capillary action. During cylinder reactivation, oil near the surface is burned off, while soot (carbon deposits) is generated within clearance volumes due to incomplete combustion. During spark plug reheating, the center electrode thermally expands at a much greater rate than the insulator, causing compressive stresses within the center electrode and tensile stresses on the electrode insulator exterior. These stresses can fracture the ceramic insulator if sufficiently high. In sodium migration, sodium sulfate is created during combustion and deposits form in the clearance volume between center electrode and insulator. Currently, the source of sodium sulfate is not known, although it is believed to originate from E100 fuel. Present theory suggests that failure is caused by electrode/insulator locking, where electrode and insulator are mechanically joined by the sodium sulfate. During cool down, the electrode contracts and increases in diameter, which pushes (via sodium sulfate) against the insulator and causes failure in the same manner as seen in oil migration.

- Install new spark plugs.

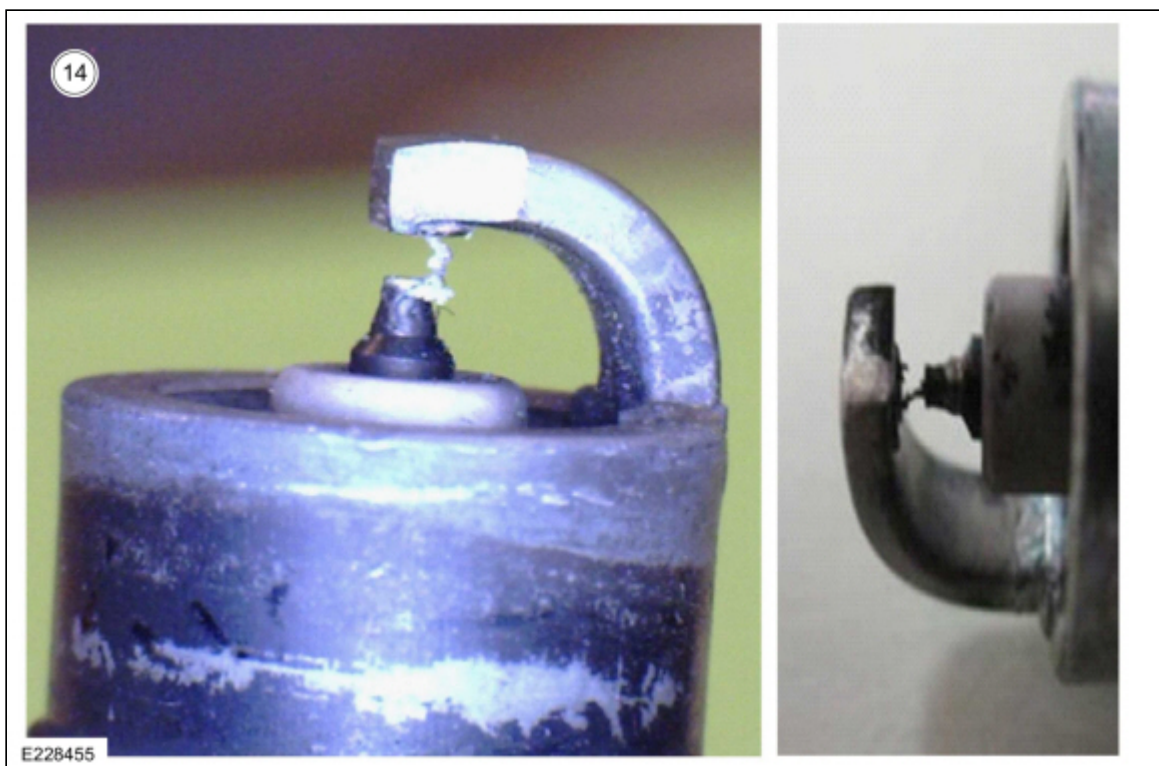
### Bridged Gap

- A bridged spark plug gap is often caused by fuel droplets present in the ion gap when spark is commanded. The spark event conducts through the fuel droplet leaving behind a carbon fiber. Other contributors include deposit build up on the electrode surface which is indicative of carbon or oil fouling. Often, this condition can present itself after many low and medium load cycles. Carbon deposits within the combustion chamber can break free during sudden applications of high load, lodge within the spark plug gap, and provide a dead short to ground.
- Install new spark plugs.
- A drive of between 4-10 miles targeting 3000 rpm will bring the plug to self-cleaning temperature.

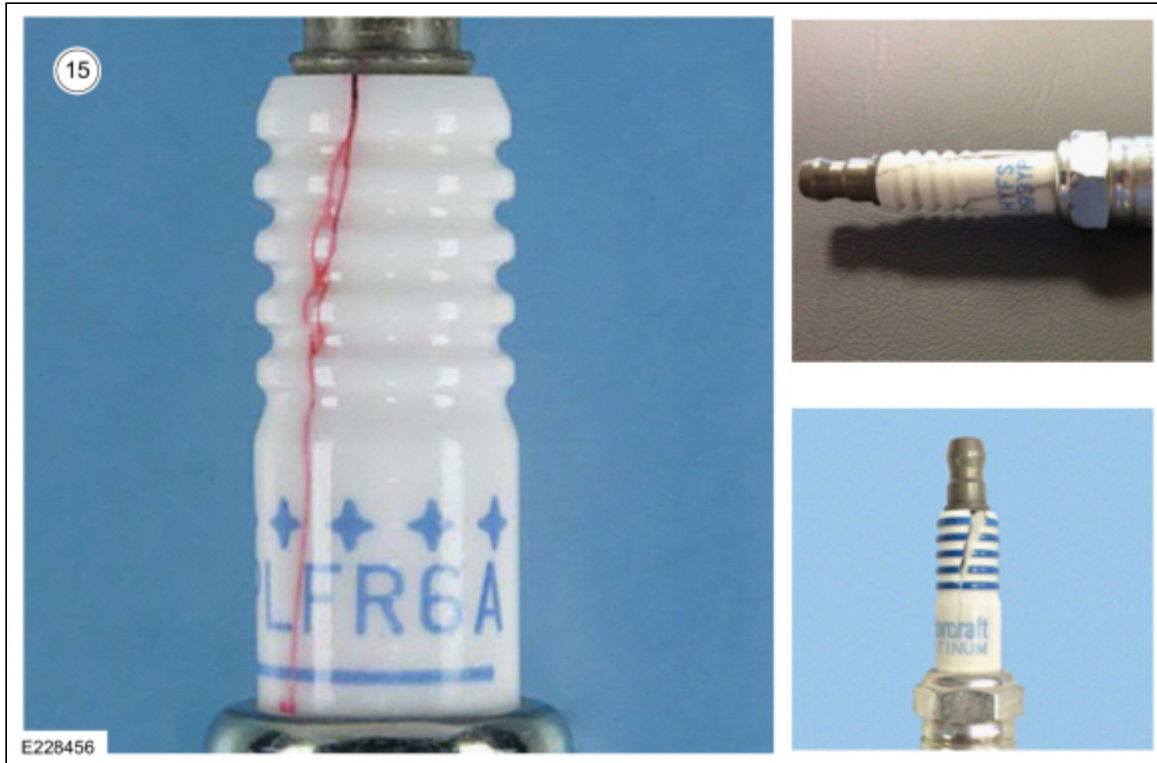
## Wrench Breaking Cracks

- Wrench breaking cracks are typically caused either by side load or torque applied from a socket of incorrect size. Impact loading can and will often crack the insulator shell as the porcelain is very brittle with very little strength under tension. Force direction is often easily determined as the ceramic often cracks vertically (although typically asymmetric about the centerline).
- Avoid using anything but a spark plug socket and hand tools to better prevent these cracks.
- Install new spark plugs.

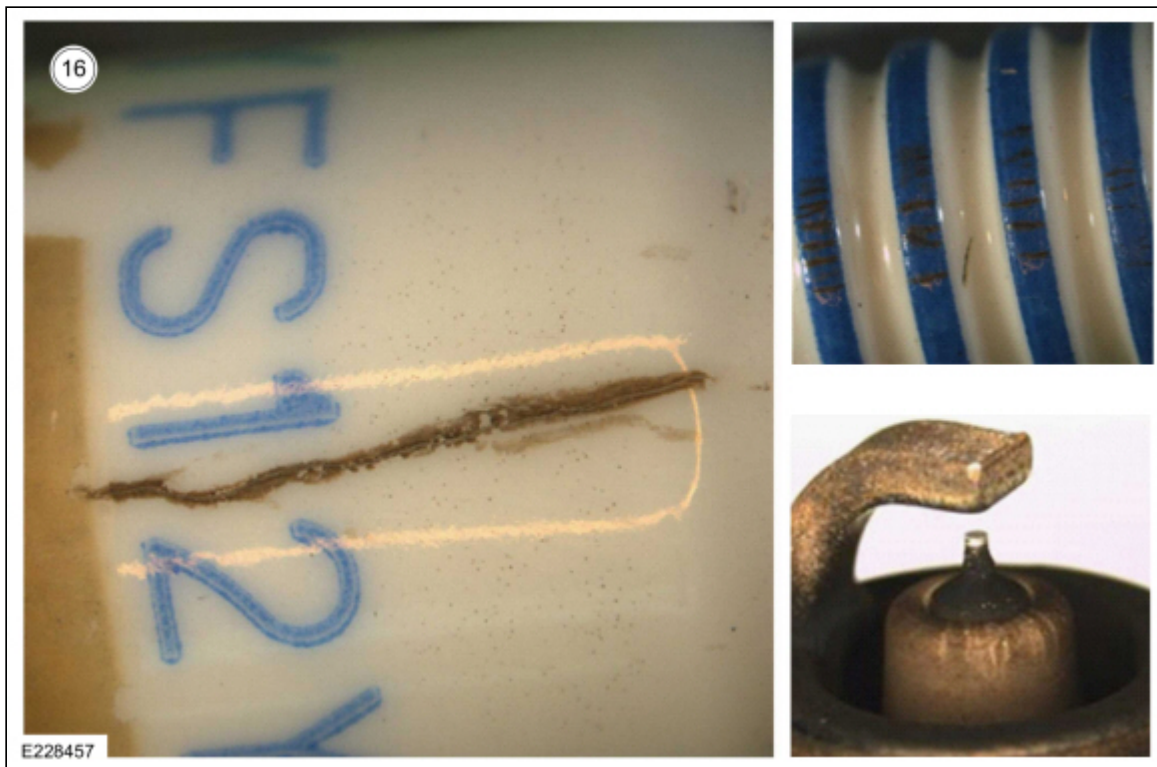
## Tracking/Flashover

- Tracking marks are markings left behind when a high voltage discharge occurs from electrode to ground through something other than the air gap at the spark plug end. Most often, these discharges occur along the primary insulator (under/near the boot) and on the center electrode insulator. These discharges typically scorch the porcelain ceramic and leave a brown burned visual indicator. In the primary photo, a large brown scorch mark is apparent. In the upper secondary photo, track marks are present along each rib. In the lower secondary photo, which shows a case of typical carbon fouling, track marks are present along the primary center electrode insulator as the spark current tracked along the insulator until it jumped sideways to the metal shell.

- Install new spark plugs.
- Install new ignition coil boot (if tracking is above the hex).
- If tracking is present above the hex, both of the above parts must be changed at the same time because the track is present on both components. If only one is changed, the problem will persist and a return visit is very likely.

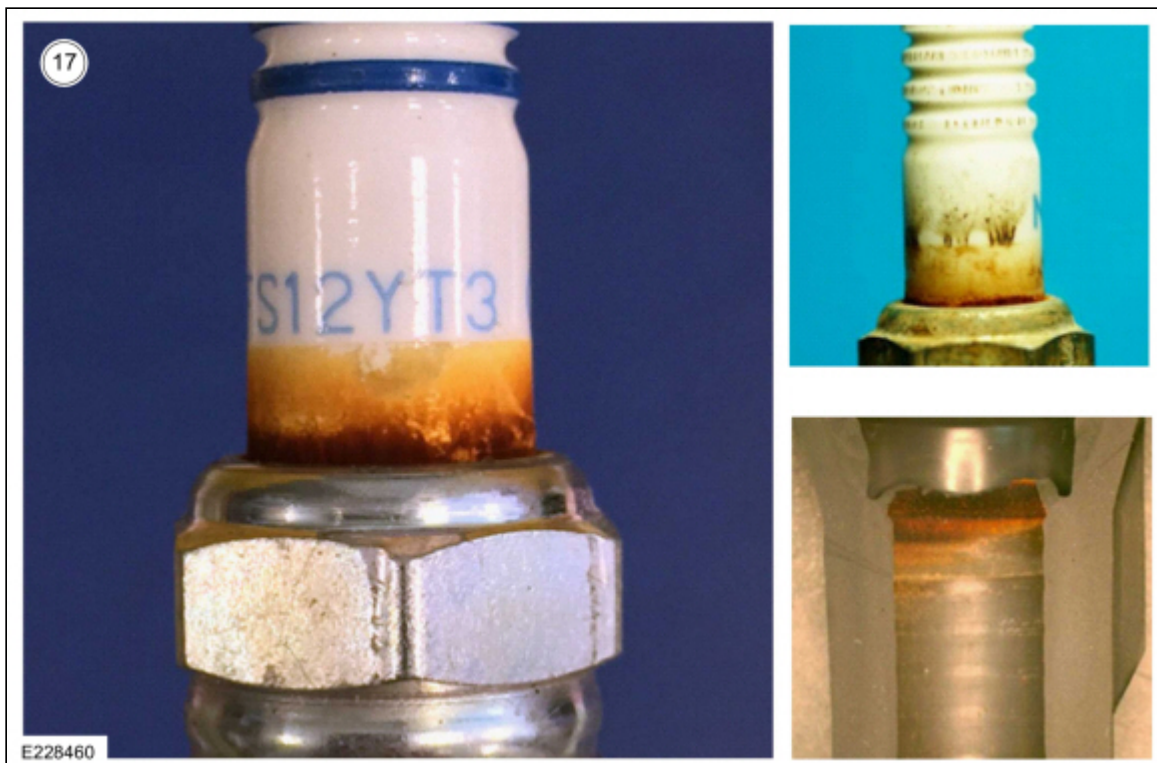
### Corona Stain

- A brown stain near where the insulator joins the metal shell of the spark plug is often called a corona stain and is produced when oil particles present in the air near the engine adhere to the insulator surface. Corona discharge occurs when high voltage applied to the conductor on top of the spark plug causes an insulation breakdown of the air gap between the insulator and metal shell. Corona stain does not affect spark plug performance. In the upper right photograph, tracking marks are present indicating evidence of flash over on ribs, but stop once the corona stain is reached. This suggests the corona stain is not conductive, even in the presence of high kilovolts during normal operation. The lower right photo demonstrates corona staining on the inside of a boot.
- No corrective action is necessary if only a corona stain is present.

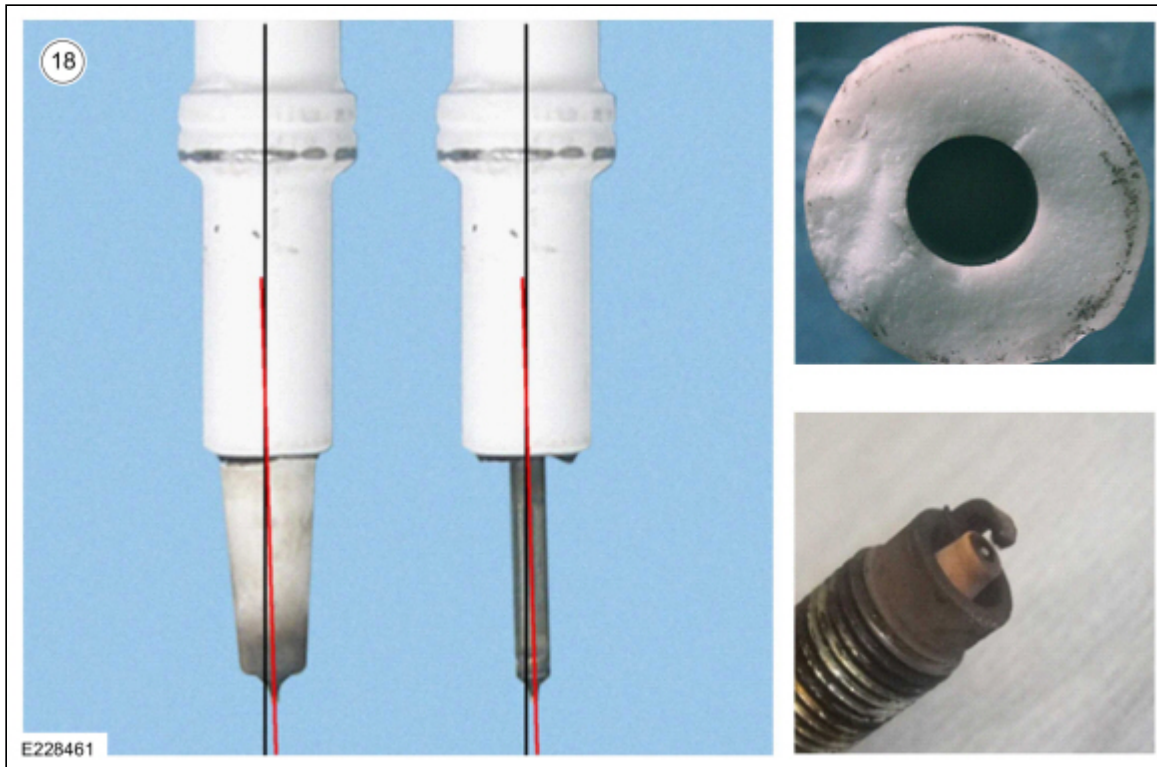
## Center Electrode Bending/Breaking from Pre-Ignition Events (Rattler)

- Under extreme pre-ignition events, a shock wave traveling across the combustion chamber can bend the center electrode and break the center electrode porcelain insulator. Under these extreme circumstances, a “rattler” can be formed where the center electrode insulation breaks free of the spark plug and rattles under vibration. In the photos, a bent center electrode is highlighted in the main photo while the upper secondary photo shows the fracture surface of a broken insulator and the lower secondary photo shows a spark plug with a detached center electrode insulator.
- Install new spark plugs.

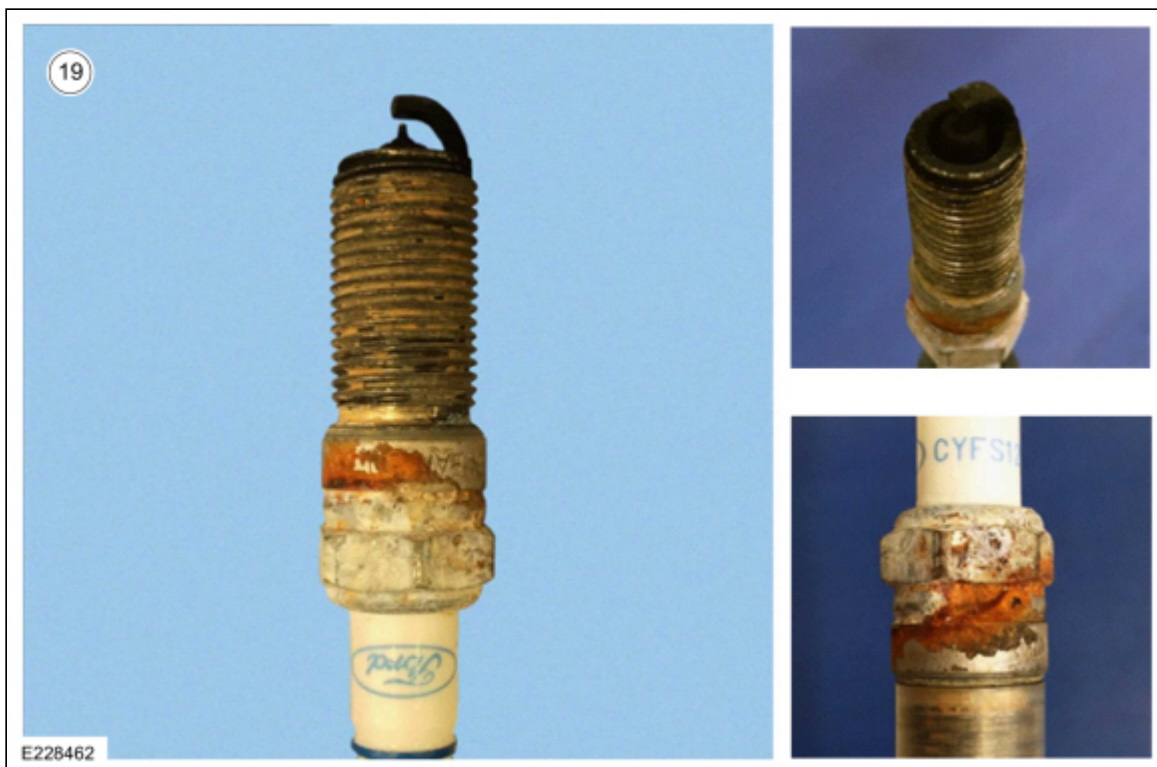
## Corrosion (Water Damage)

- Corrosion found on the wrench/threaded area can be a sign that the spark plug has experienced moisture and heat. Often this condition occurs when water has penetrated spark plug tube seals and entered the spark plug tube. Many times, this corroded spark plug also displays symptoms of misfire (as water provides a low resistance path from high voltage coil to ground) and the combustion chamber interface (center electrode and ground strap) will often be heavily carbon fouled.
- Check for the source of water intrusion and correct as necessary.
- Install new spark plugs.
- Install new ignition coil and boot assembly.
- Advise the customer to avoid direct water spray on the coil boots.
