**Audio Unit Antenna Cable****Materials**

**Instrument panel antenna cable**

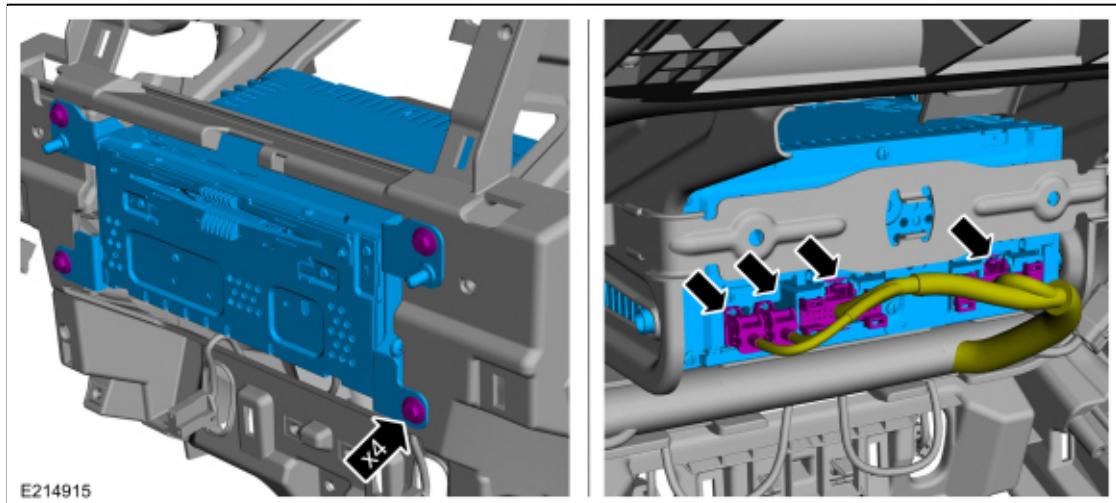
1. Remove the FCDIM or FDIM.  
Refer to: [Front Control/Display Interface Module \(FCDIM\)](#) (415-00B Information and Entertainment System - General Information - Vehicles With: SYNC 3, Removal and Installation).  
Refer to: [Front Display Interface Module \(FDIM\)](#) (415-00B Information and Entertainment System - General Information - Vehicles With: SYNC 3, Removal and Installation).
2. Remove the screws, disconnect the electrical connectors and reeve the ACM.  
*Torque: 27 lb.in (3 Nm)*

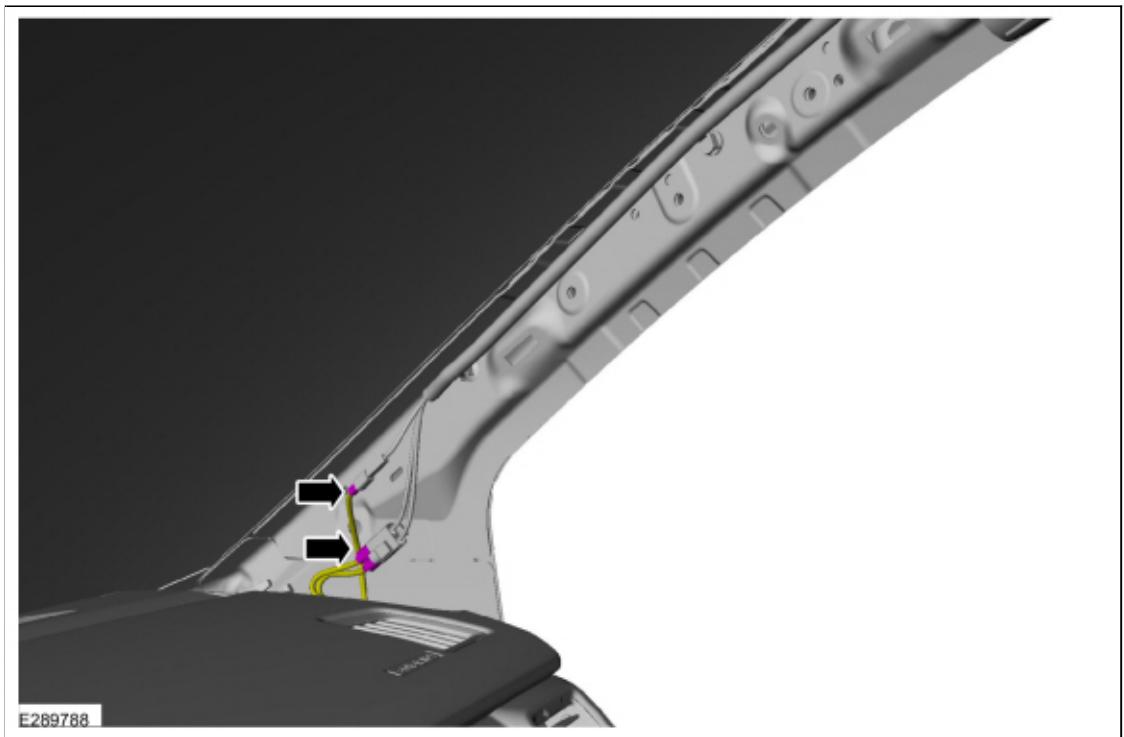
3. Remove the RH A-pillar trim panel.  
Refer to: [A-Pillar Trim Panel](#) (501-05 Interior Trim and Ornamentation, Removal and Installation).
4. Disconnect the in-line connectors.

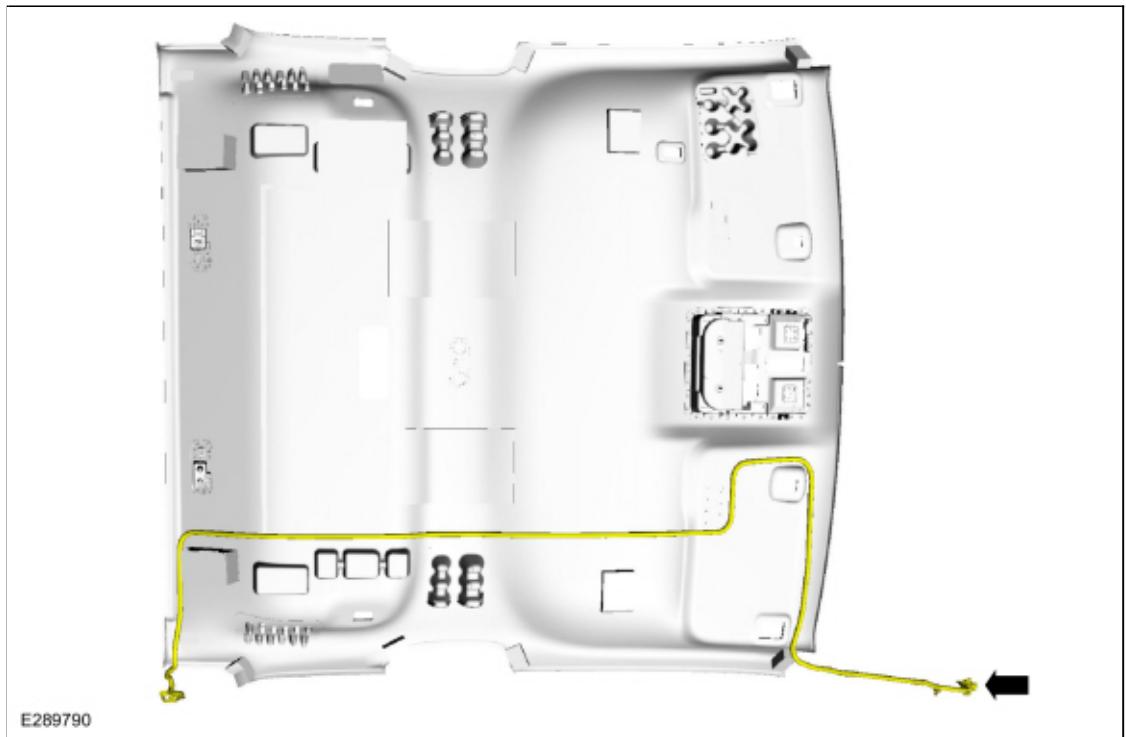
7. Remove the headliner.  
Refer to: [Headliner - SuperCab](#) (501-05 Interior Trim and Ornamentation, Removal and Installation).  
Refer to: [Headliner - SuperCab](#) (501-05 Interior Trim and Ornamentation, Removal and Installation).
8. **NOTE:** *Supercab headliner routing shown, all other routings similar.*

Remove the audio unit antenna cable.

1. Using tape, mark the audio unit antenna cable at the exit points for proper length from headliner-to-body/ roof connectors.
2. Carefully remove the audio unit antenna cable from the headliner.

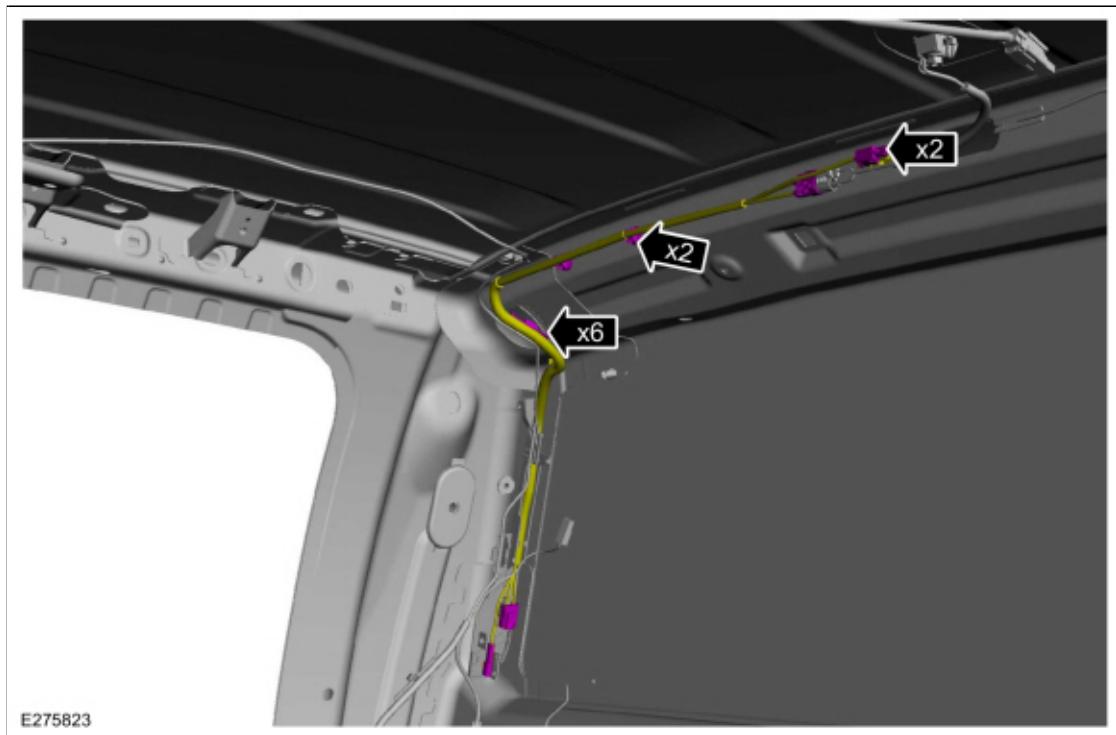
9. Remove the headliner.  
Refer to: [Loadspace Trim Panel - SuperCab](#) (501-05 Interior Trim and Ornamentation, Removal and Installation).  
Refer to: [Headliner - SuperCab](#) (501-05 Interior Trim and Ornamentation, Removal and Installation).
10. Disconnect the electrical connectors, separate the cable guides and remove the rear audio unit antenna cable.

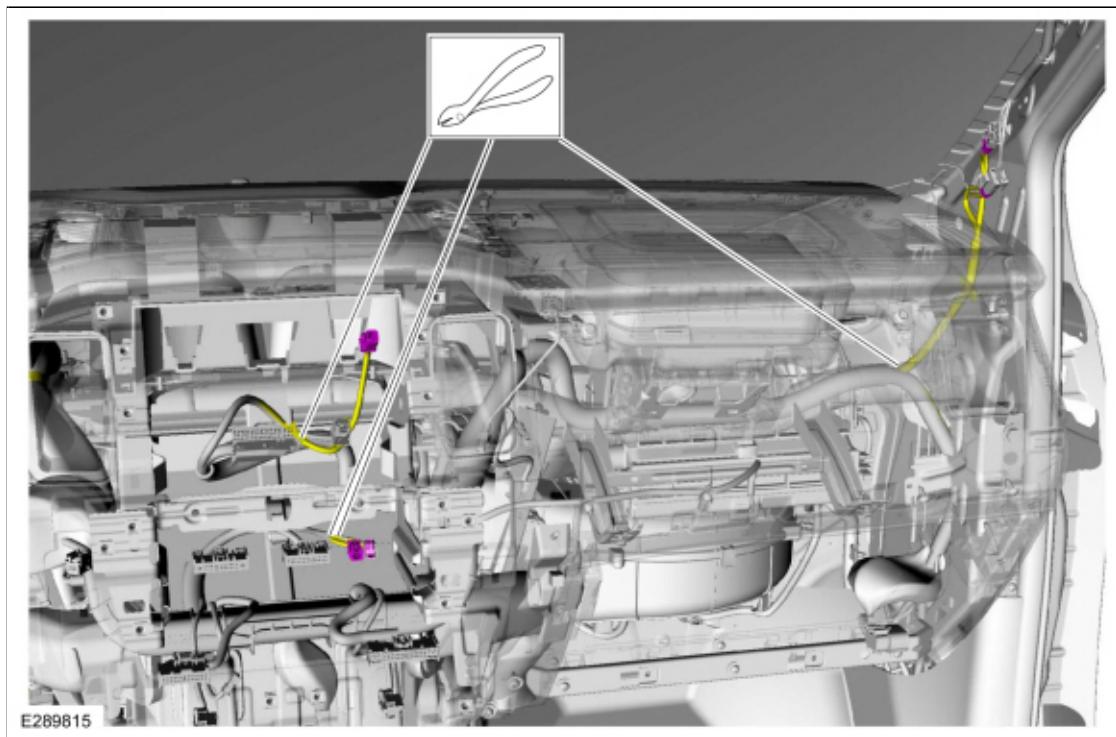
1. Cut the connector ends off the audio unit antenna cable.

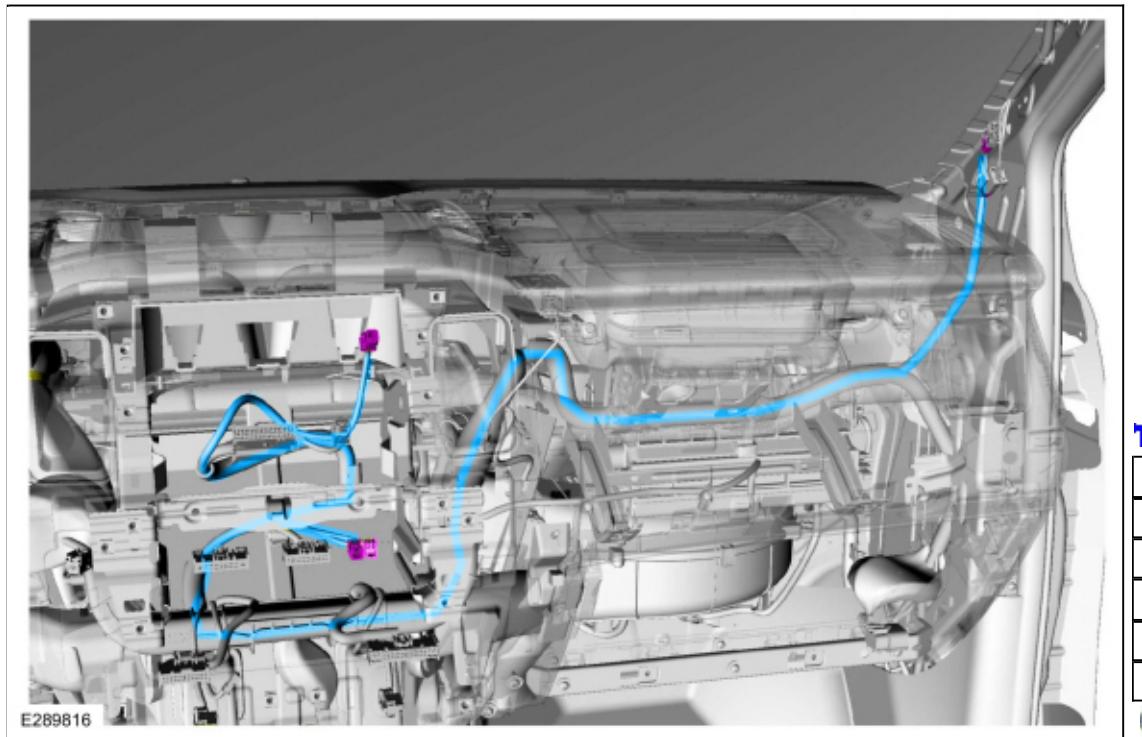
2. Overlay using the routing shown and secure the new audio unit antenna cable to the instrument panel wiring harness, as necessary to prevent NVH concerns.

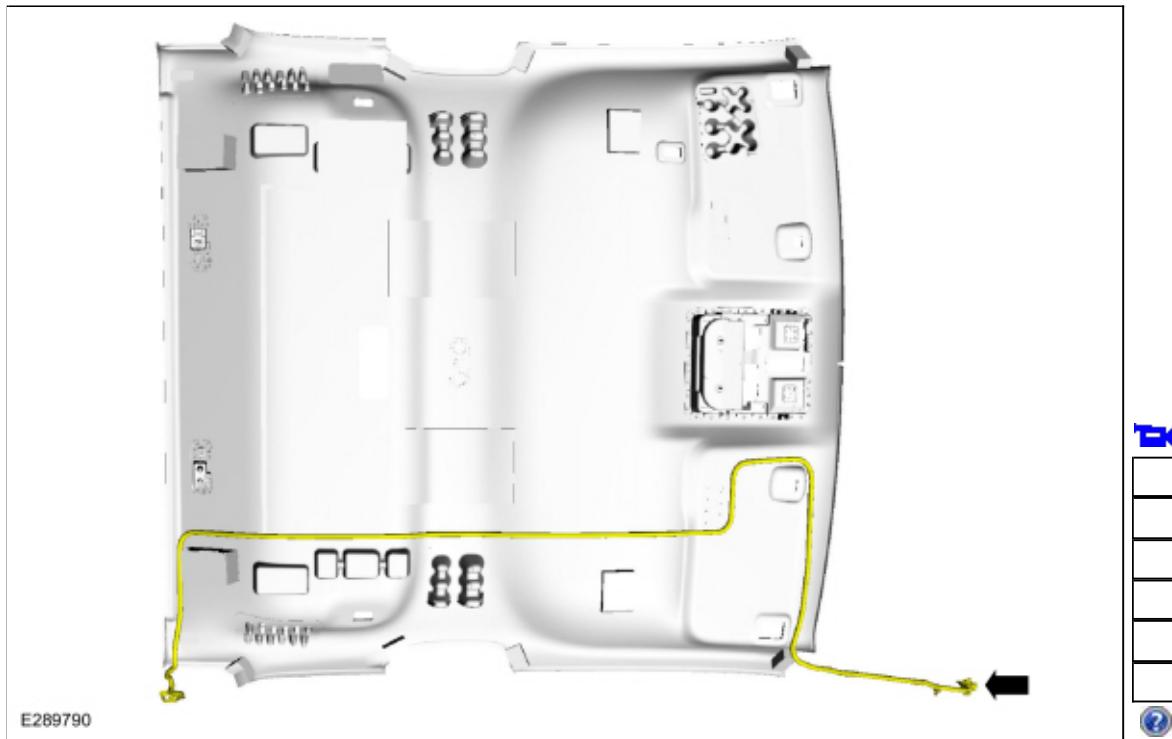
4. **NOTE:** Supercab headliner routing shown, all other routings similar.

Install the audio unit antenna cable onto the headliner.

1. Position the new audio unit antenna cable onto the headliner, making sure the cable has enough length to be connected to the body/ roof connectors at the tape location(s) applied earlier. Apply tape to temporarily hold the audio unit antenna cable in position on the headliner.
2. Apply the adhesive in the same location as the factory installed adhesive along the full length of the antenna cable-to-headliner to avoid any NVH concern(s).

*Material: 3M™ Super-Fast Repair Adhesive / 04747*
