Automotive Audio Bus (AAB) Cable**Removal****Instrument panel automotive audio bus (AAB) cable**

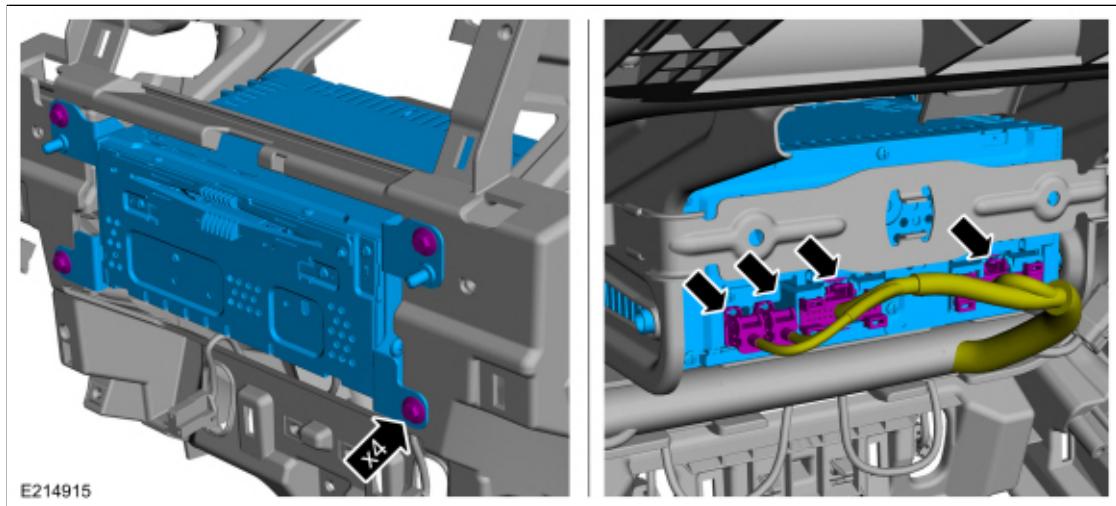
2. Remove the screws, disconnect the electrical connectors and reove the ACM.

Torque: 27 lb.in (3 Nm)

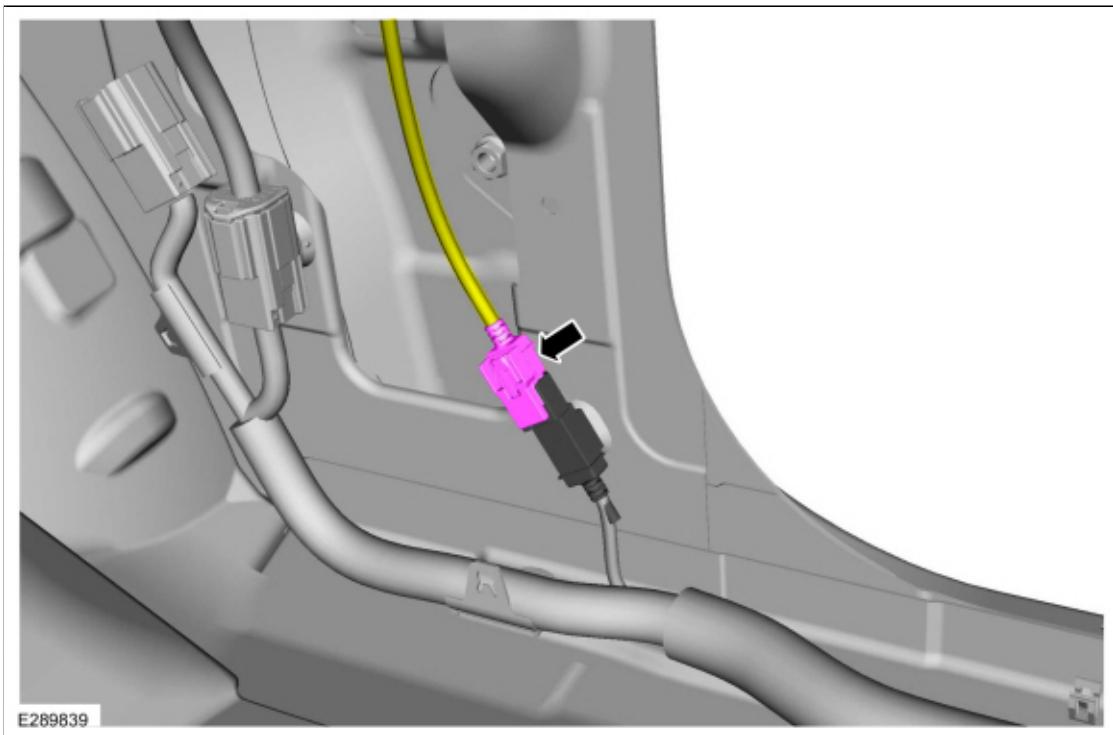
6. Disconnect the electrical connector.

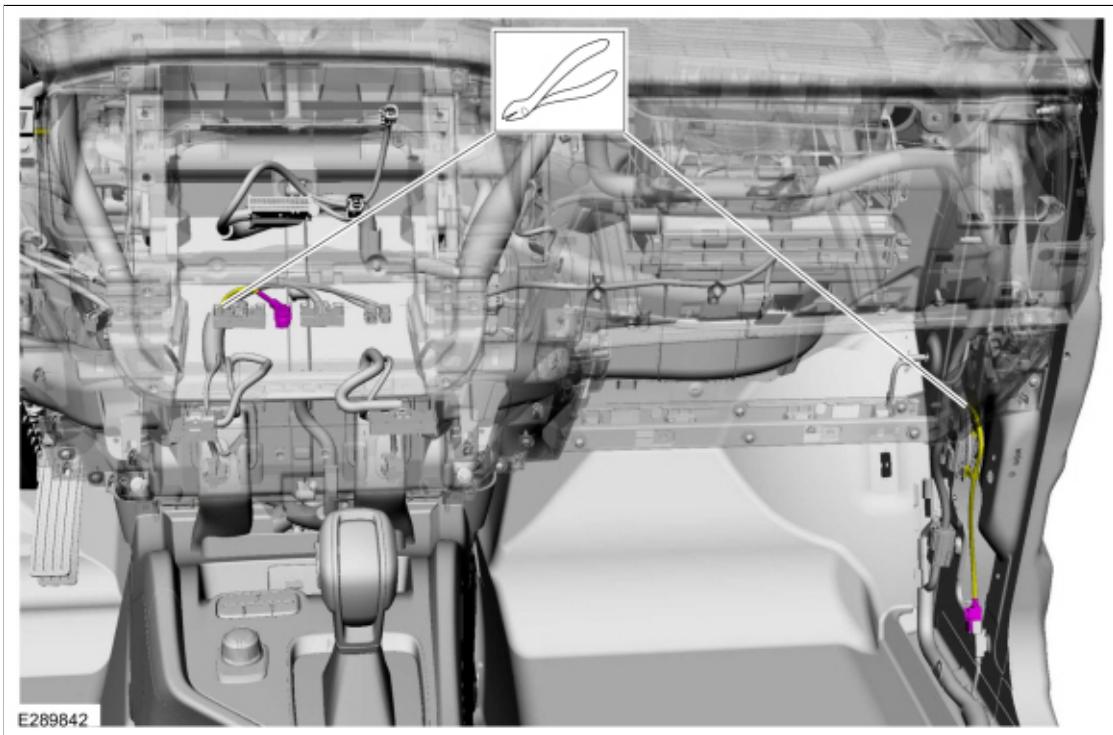
7. Trim the connectors off where the wires enter the wiring harness.

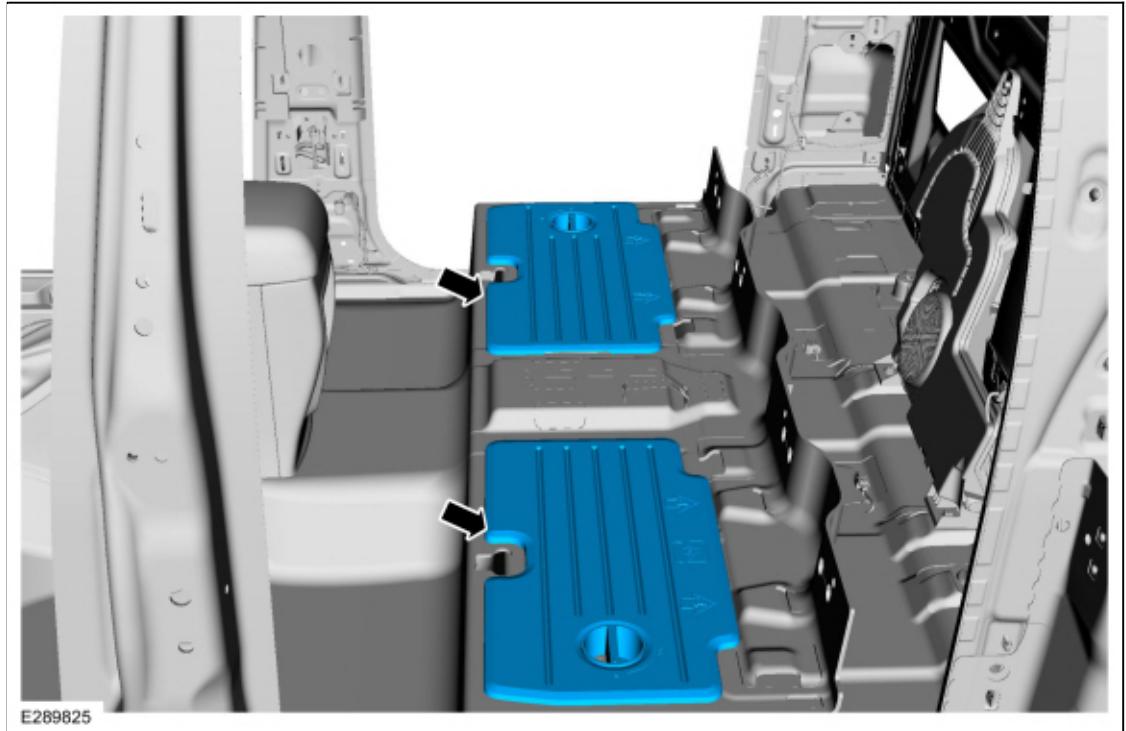
11. Remove the under seat storage compartment lids.

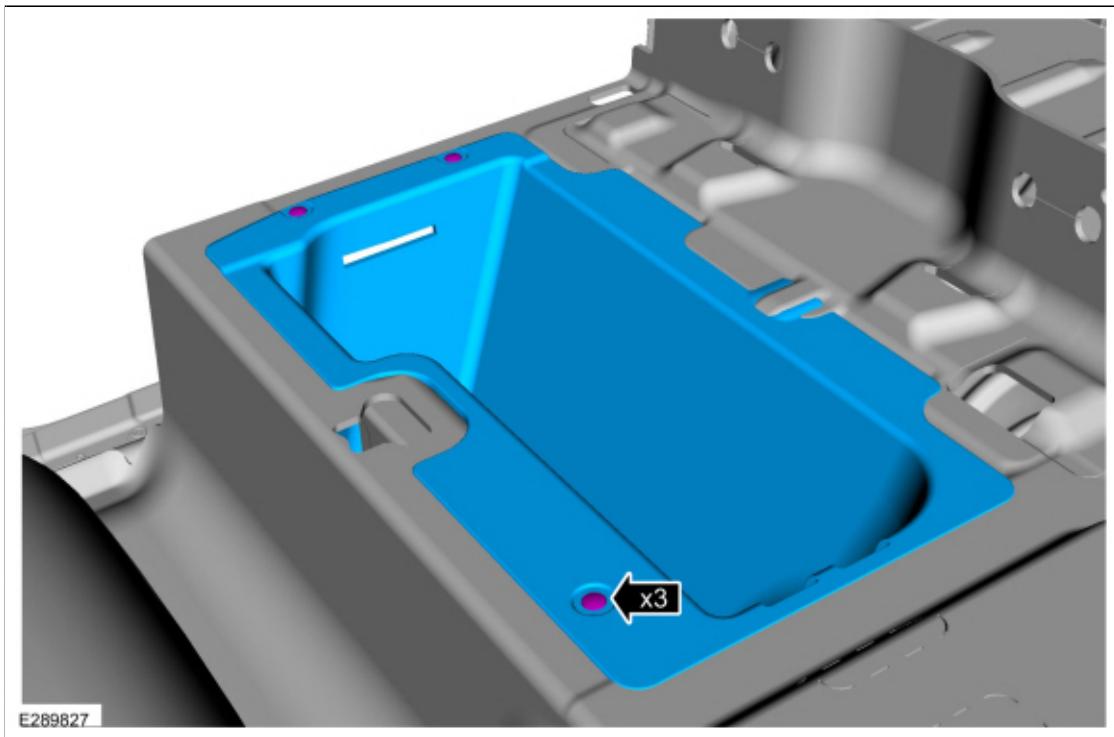
12. Remove the pin-type retainers and both under seat storage compartments.

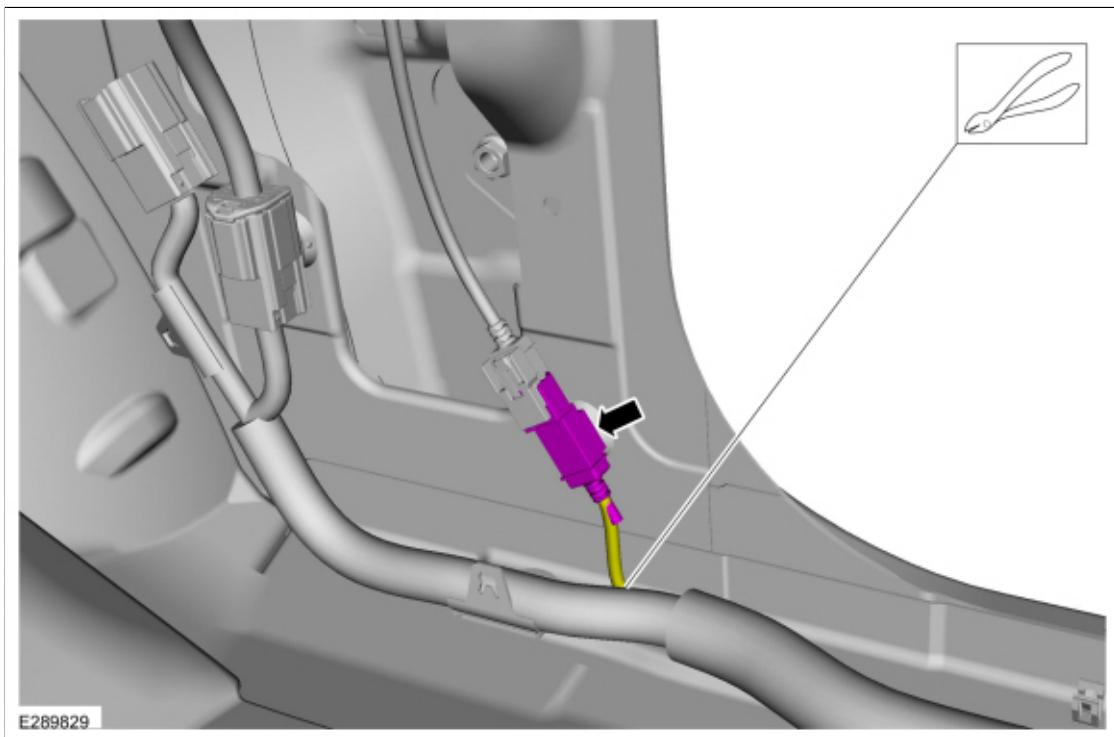
13. Disconnect and trim the electrical connector from the main body harness.

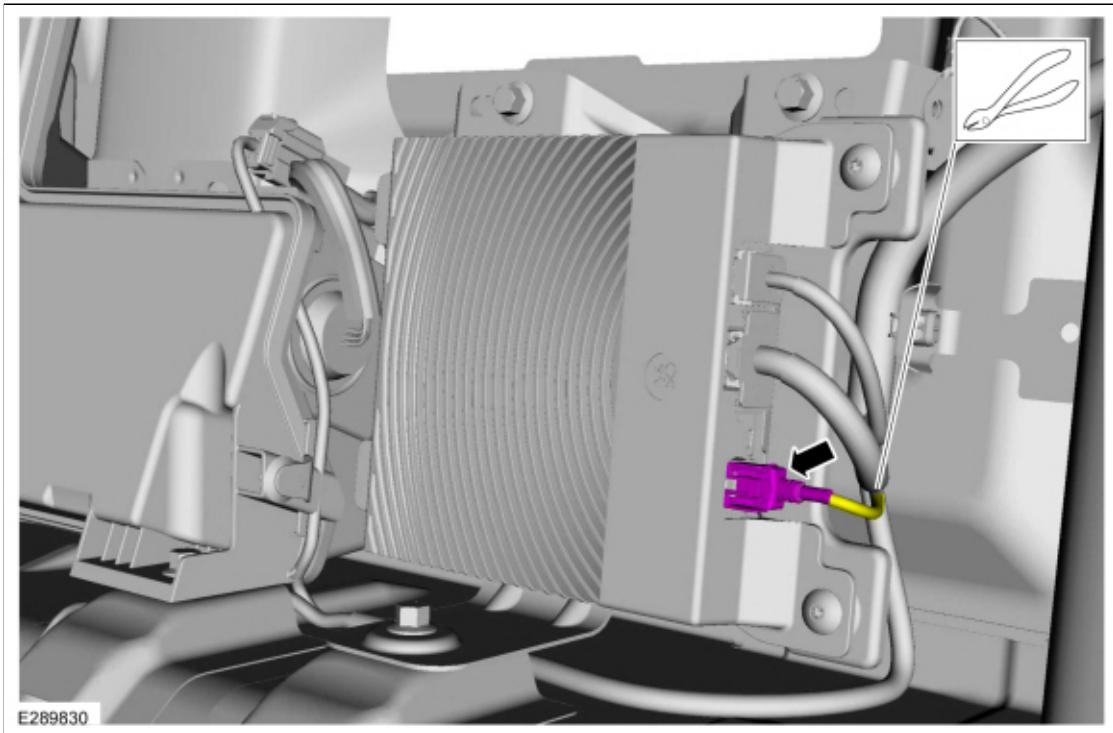
14. Disconnect and trim the electrical connector from the main body harness.

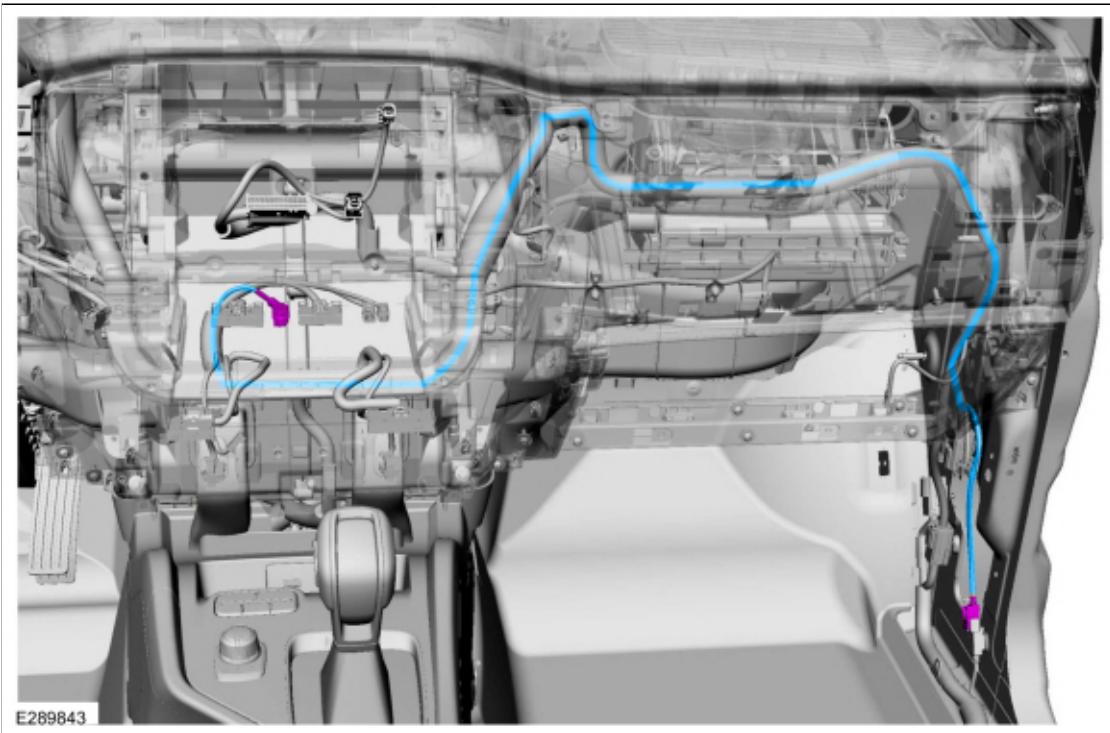
1. Overlay using the routing shown and secure the new automotive audio bus (AAB) cable to the instrument panel wiring harness, as necessary to prevent NVH concerns.

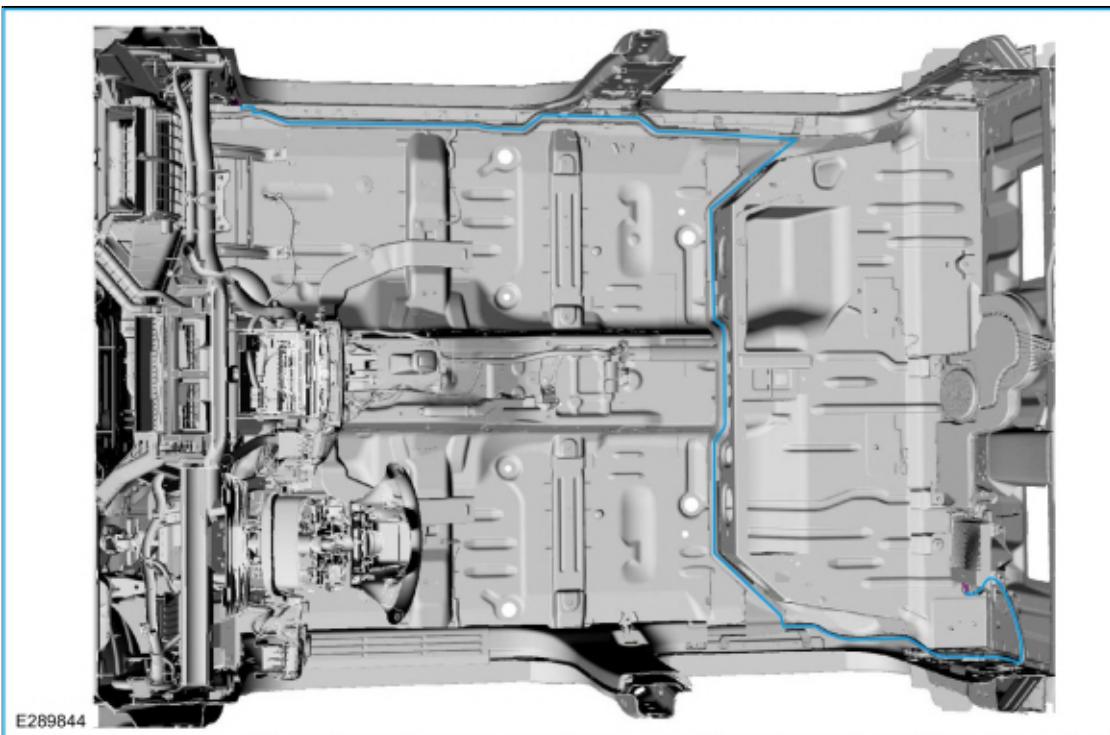
2. Overlay using the routing shown and secure the new automotive audio bus (AAB) cable to the body wiring harness, as necessary to prevent NVH concerns.
